UNDERWATER BRIDGE INSPECTION REPORT

STRUCTURE NO. 73533

SAUK RIVER

DISTRICT 3 - STEARNS COUNTY

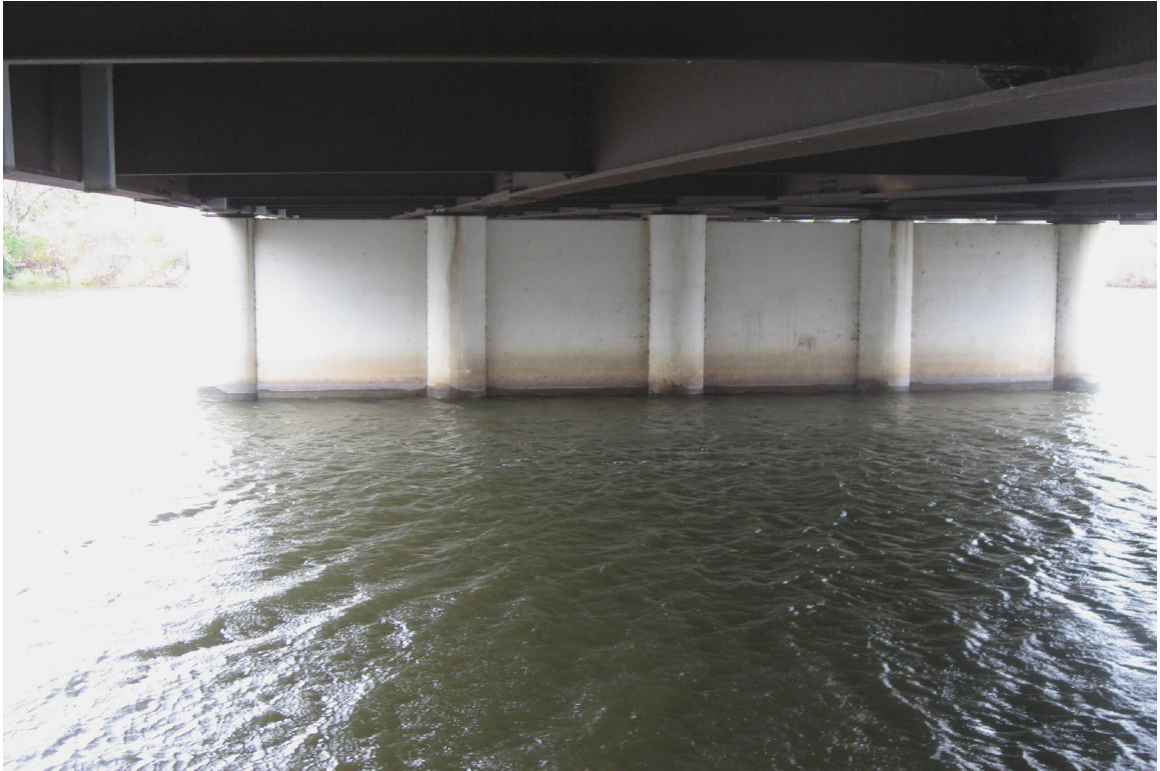
Photograph 1. View of Pier 1, Looking Northeast.

- (A) The concrete of the piers was in good and sound condition with no notable defects.
- (B) A minor accumulation of timber debris consisting of branches 3 inches in diameter and smaller was observed around the upstream nose of Pier 2.

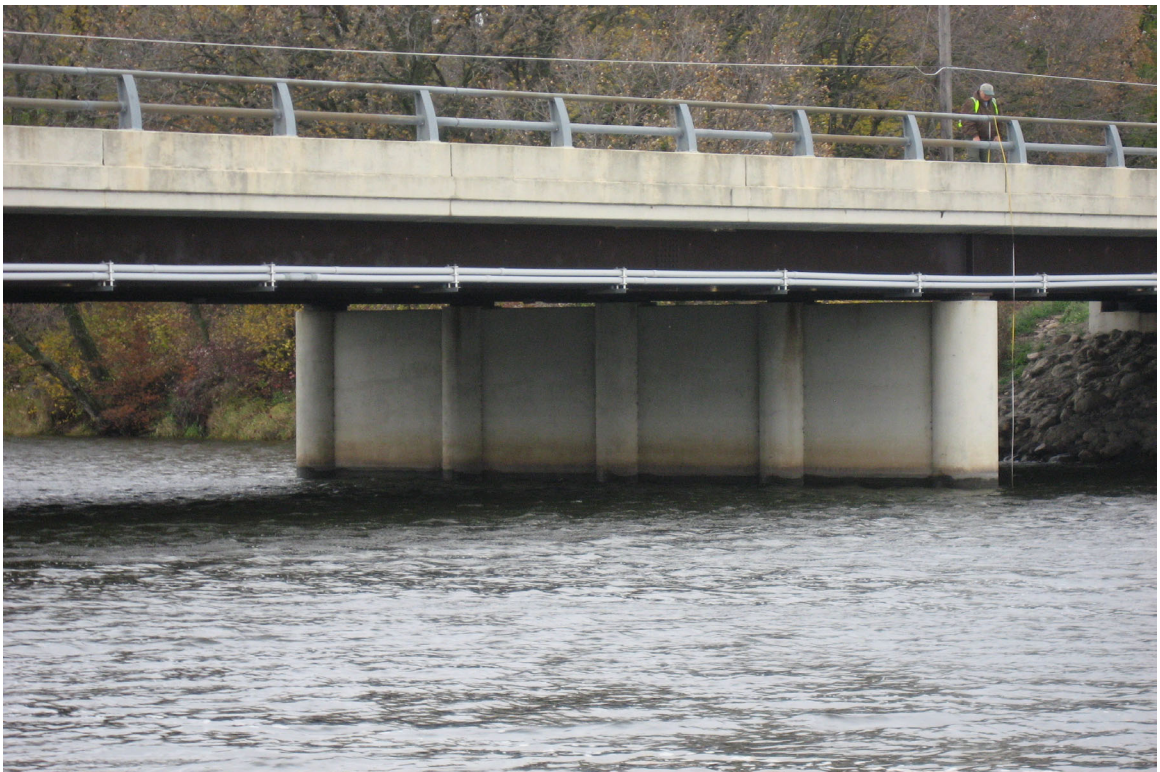
Photograph 2. View of Pier 2, Looking North.

A minor accumulation of branchy timber debris was observed around the upstream nose of
Pier 2. The channel bottom appeared to be in stable condition with no appreciable changes
since the previous inspection.
